Summary of Nominal Mission Phase

January 2009

SELENE Mission Operation

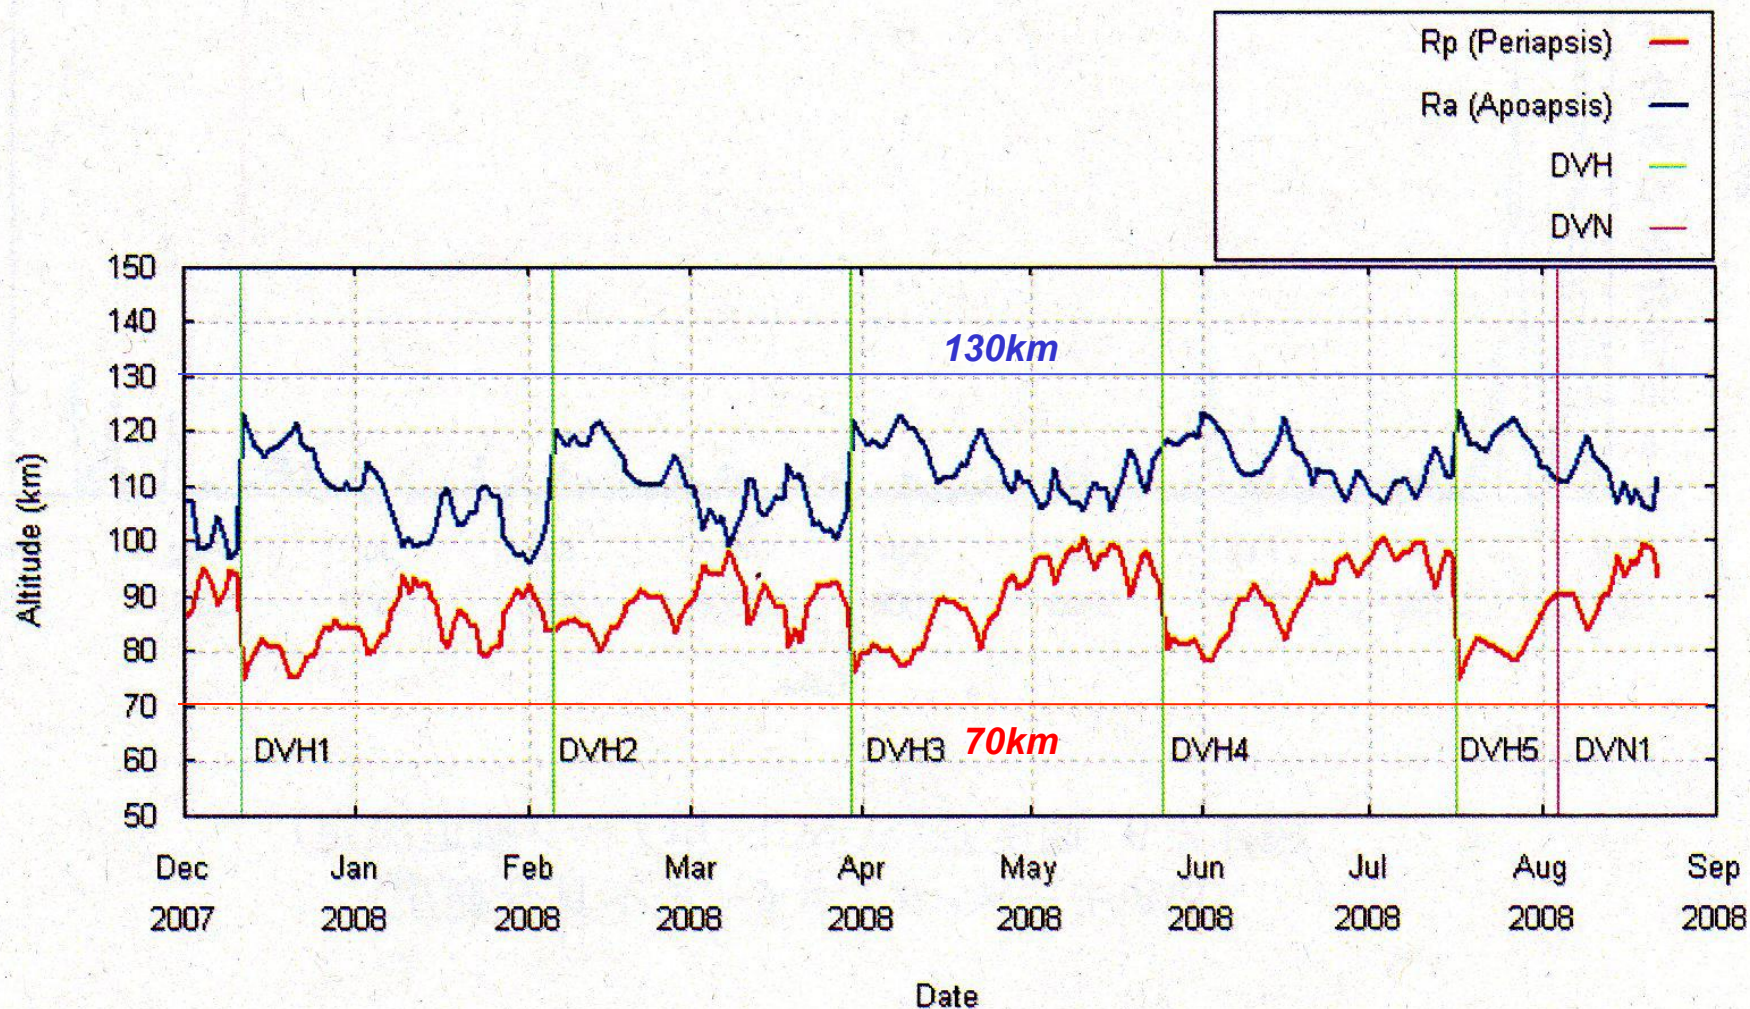
Orbit Maintenance History

<i>Function</i>	<i>Performance</i>
<i>Orbit Maintenance</i>	<i>altitude control maneuver 5 times, keeping 100±30 km as planned plane control 3 times as planned</i>
<i>Attitude Control</i>	<i>three axis control (moon pointing) within ±0.1° as planned RW#1 failed July 2008, but three others worked, satisfying observation requirements.</i>
<i>Power Generation and Supply</i>	<i>Power generation as planned DOD<21% (nominal operation) in specification DOD<60% (eclipse) in specification</i>
<i>Data Management</i>	<i>worked as planned</i>
<i>Thermal Control</i>	<i>within specification</i>

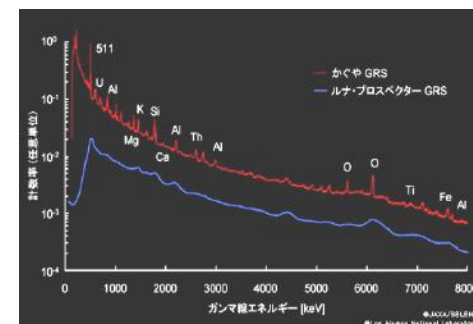
Typical energy spectrum

Element abundance for K,Th, U, Ca, Si, Ti etc., were obtained as planned. Extended observation was required due to temporal sensor problem.
Multi-band Imager
